Classification	Troubleshooting FAQ on XPAC					No.	7-002-00
Author	WeiKai	Version	1.0.0	Date	2011/4/11	Page	1/2

Q: Why an I-8000W module cannot be recognized by XPAC Utility?

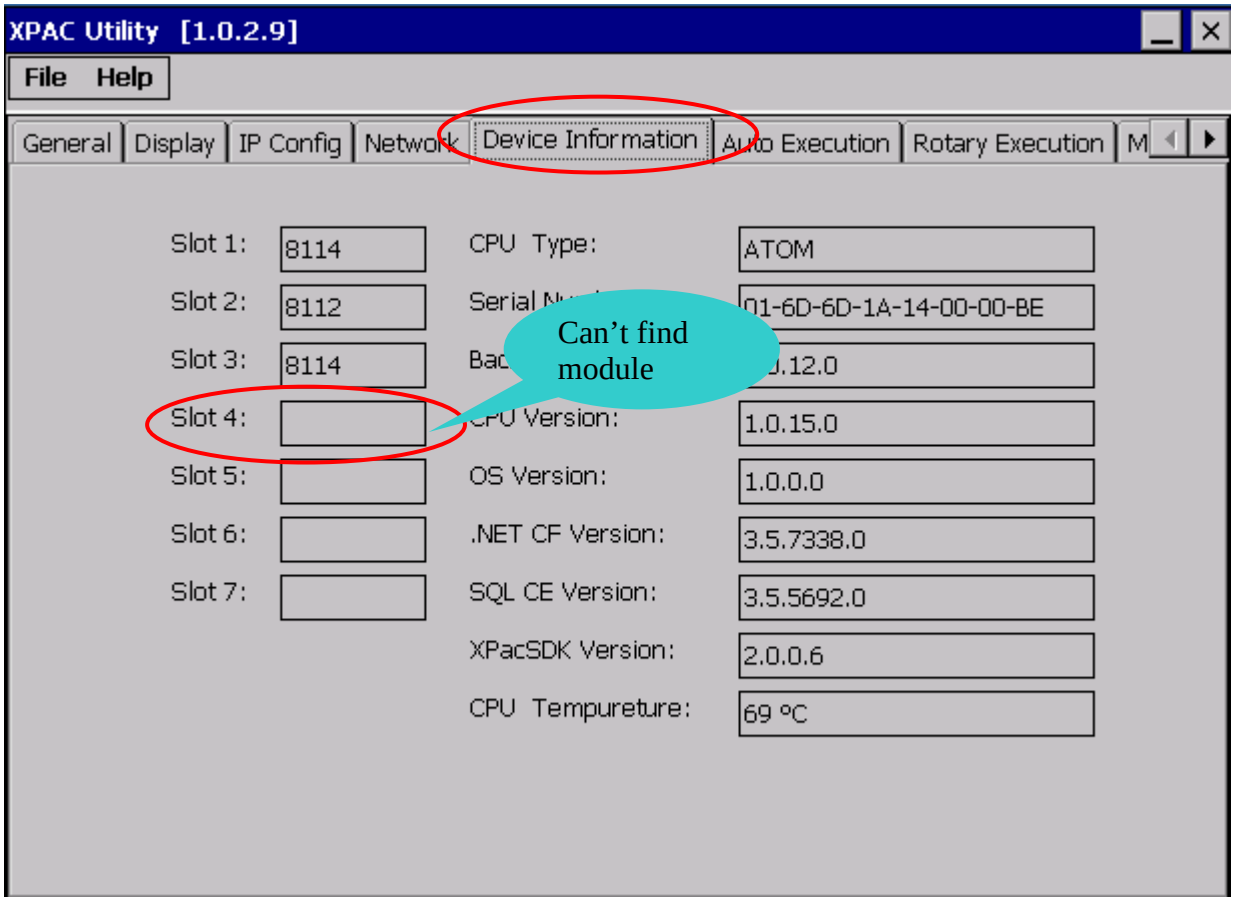
Insert an I-8000W module (ex. 8093W) on the slot of XPAC (ex. Slot 4) and run the XPAC utility. The module name of I-8093W cannot be shown in the slot text box on Device Information tab.

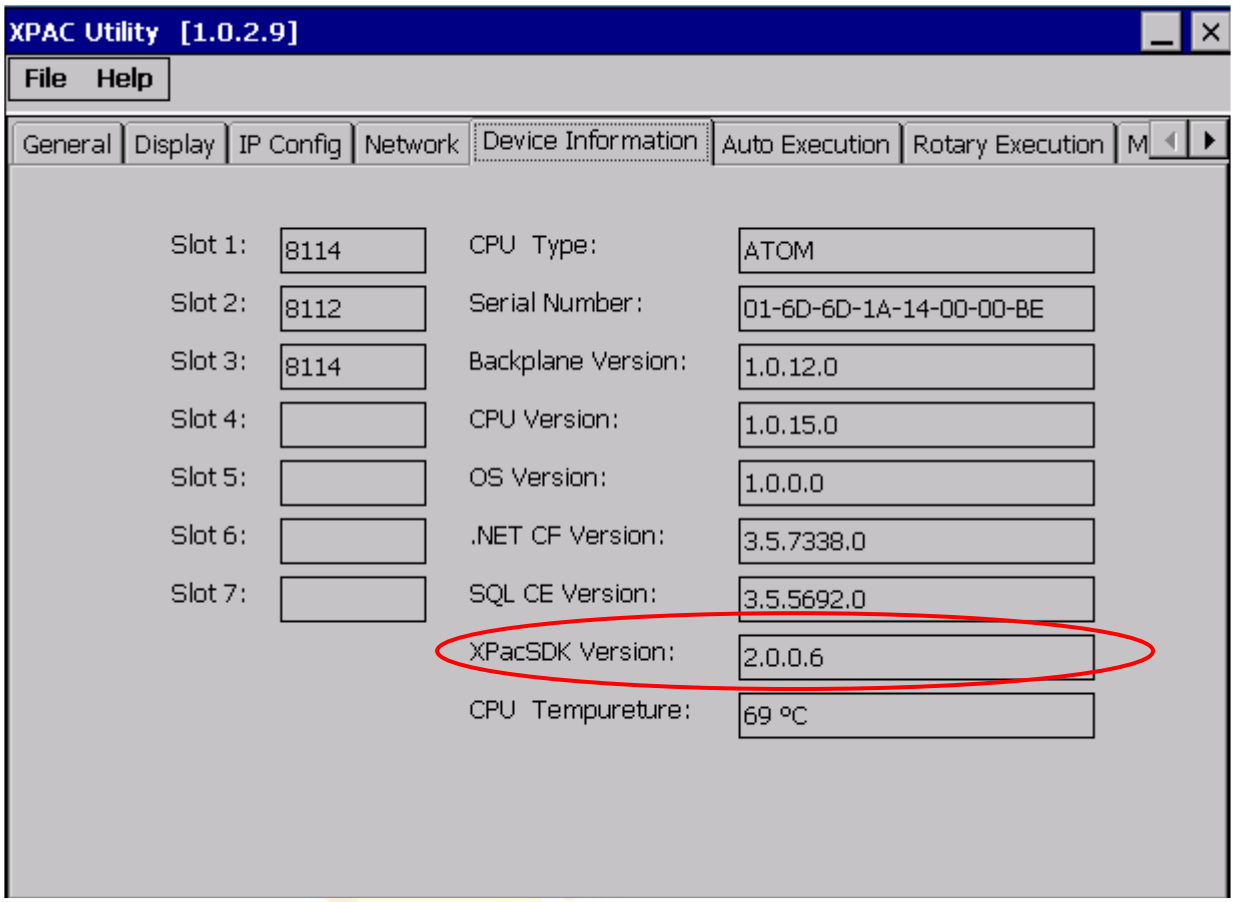
This problem is caused by using the previous version of XPACSDK.
For example, the I-8093W supported for V2007 XPACSDK.dll is just recognized by XPAC utility calling V2007 XPACSDK.dll.
If the XPAC utility calling V2006 XPACSDK, the module name of I-8093W plugged on Slot 4 of XPAC isn't shown on the "Slot 4" text box

Update SDK to resolve this problem.

Put the xpacsdk_ce.dll in \System_Disk\Tools\XPAC_Utility\ and \System_Disk\ICPDAS\System\.
